Modal Test-Based Condition Assessment

Scott J. Kangas, Arthur J. Helmicki, Victor J. Hunt, Bahram Shahrooz, and David Brown
University of Cincinnati Infrastructure Institute
ECECS Dept., ML-30, University of Cincinnati, Cincinnati, OH 45221-0030

One bridge tested, a continuous five-span reinforced concrete deck on steel-girder bridge in Dayton, Ohio, had its original deck replaced with an interlocking system of fiber reinforced polymer (FRP) panels. Impact tests were performed on the original bridge to establish baseline signatures such as natural frequencies, mode shapes and flexibility. Follow-up tests were performed on the FRP system to determine the influence the new deck had on the overall bridge behavior. Changes to the bridge characteristics could then be attributed to the existence of a lighter bridge deck, loss of unintended composite action with the deck, and unexpected delamination of the FRP panels.

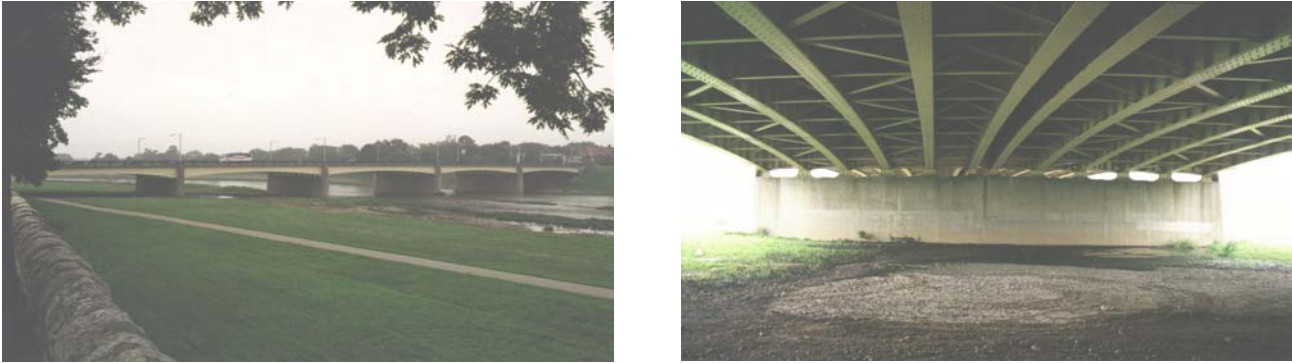
Figure 1: Overview of MOT-49-10.

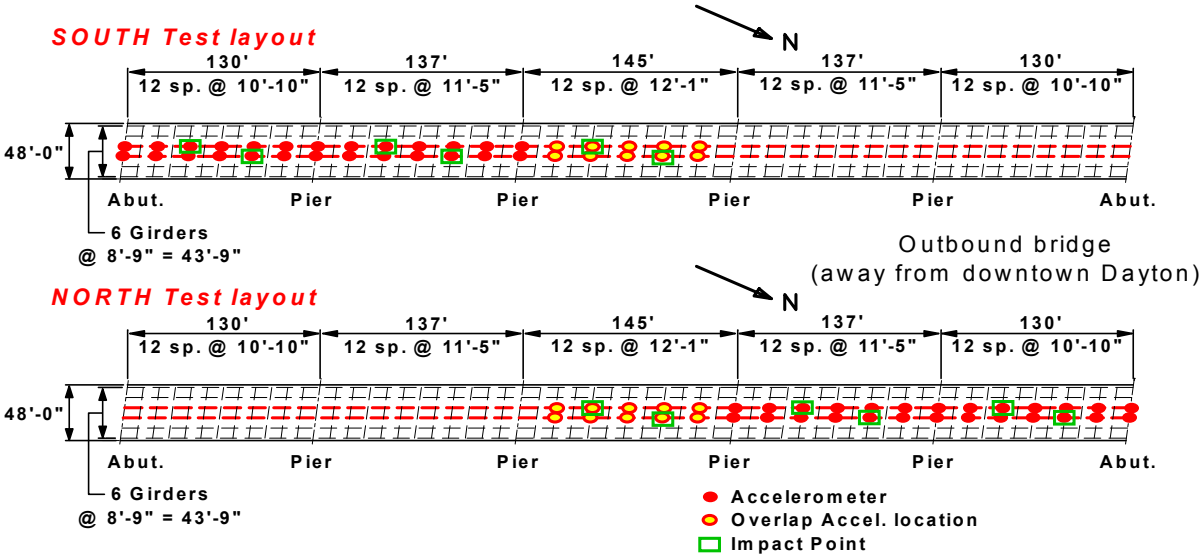
Due to the overall length of the bridge, the impact test grid for MOT-49-10 was divided into two sub-grids, North and South (Figure 2). Each sub-grid utilized 36 accelerometers mounted on the upper side of the bridge deck. These sensors were spaced at intervals that positioned them above girder-crossframe intersections and girder-bearing positions associated with the two innermost girders. Impact force was applied, through the use of a specialized, mobile impact hammer (Figure 3a), near six sensor positions in each respective sub-grid to ensure excitation of pertinent superstructure modal characteristics, i.e. mode shapes and natural frequencies. Impact force and acceleration response signals were acquired using a Hewlett-Packard (HP) VXI data acquisition

Figure 2: MOT-49 Impact Test Grids

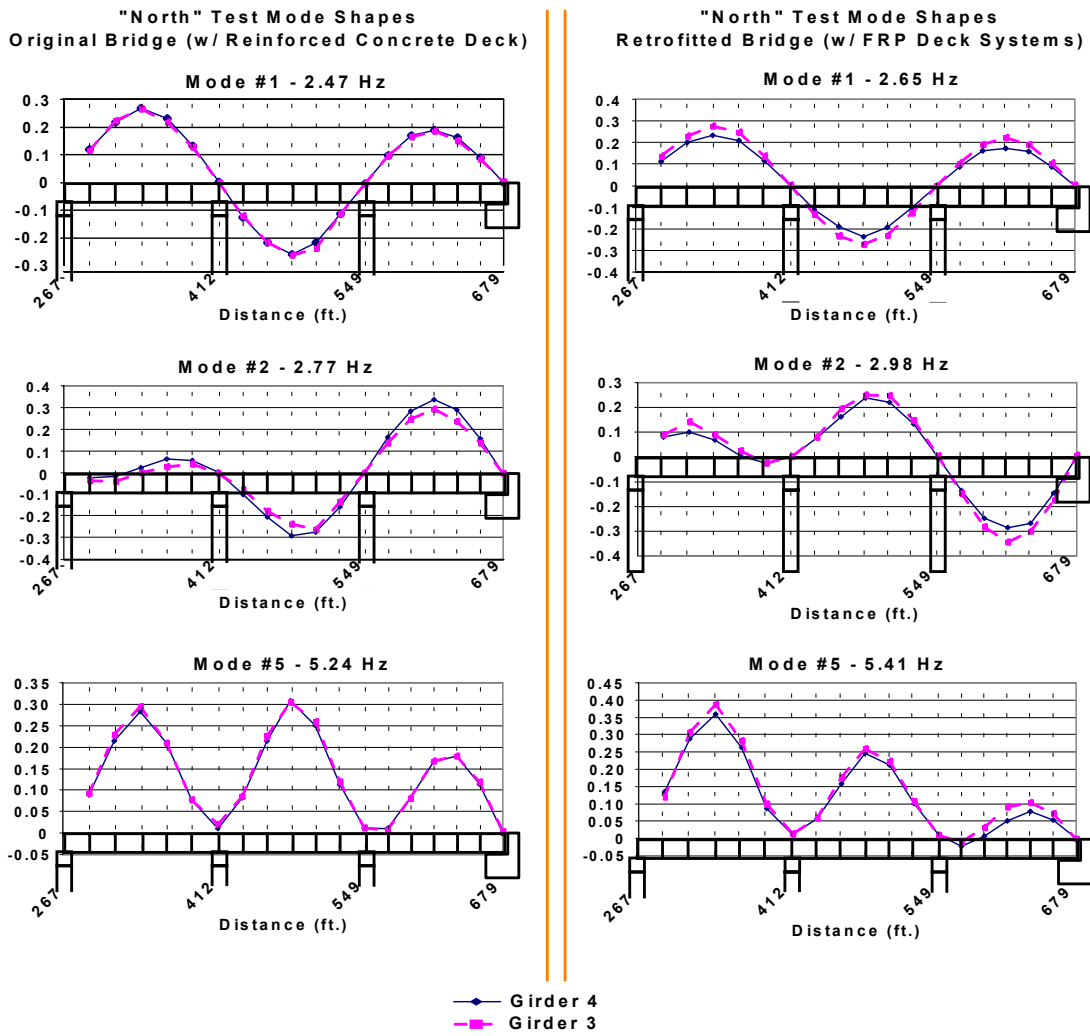
Impact test data from both the North and South grids of the original and retrofitted bridge tests was used to identify mode shapes at natural frequencies ranging from approximately 2.5 Hz to 40 Hz. Several of these modes are depicted in Figure 4. Comparisons involving the first 8 modes of the original and retrofitted bridge tests are presented in Tables 1 and 2. These tables not only provide a comparison of natural frequencies, but also display how well the respective modes correlate. The modal assurance correlation (MAC) coefficients presented within these tables indicate the similarity between a pair of respective modes – a value of zero, or N/A, indicates there does not exist a pair of similar modes whereas a value of 1 indicates perfect similarity between the pair of identified mode shapes.

As can be seen in Tables 1 and 2, certain mode shapes identified with retrofitted bridge data were not identified from original bridge data and vice versa. Furthermore, the North and South retrofit results presented in these tables reveal that the southernmost spans – the spans that use interlocking FRP deck panels – have slightly different modal characteristics than the northernmost spans which utilize cast-in-place concrete with stay-in-place fiberglass forms and fiberglass rebar. In other words, the type of FRP system installed on the bridge has a local effect on the dynamic behavior of the superstructure – different FRP systems have different local effects. Consequently, the results presented within Tables 1 and 2 essentially reveal that the dynamic behavior of the superstructure changes when the reinforced concrete deck is replaced with FRP systems. The identified variations in dynamic behavior may be attributed to changes in superstructure stiffness induced through the FRP retrofit operations. However, changes in superstructure stiffness should also be reflected in the acquired/identified measurements of in-situ structural flexibility, or modal flexibility.

Figure 4: North test mode shapes identified for original and retrofitted bridge.

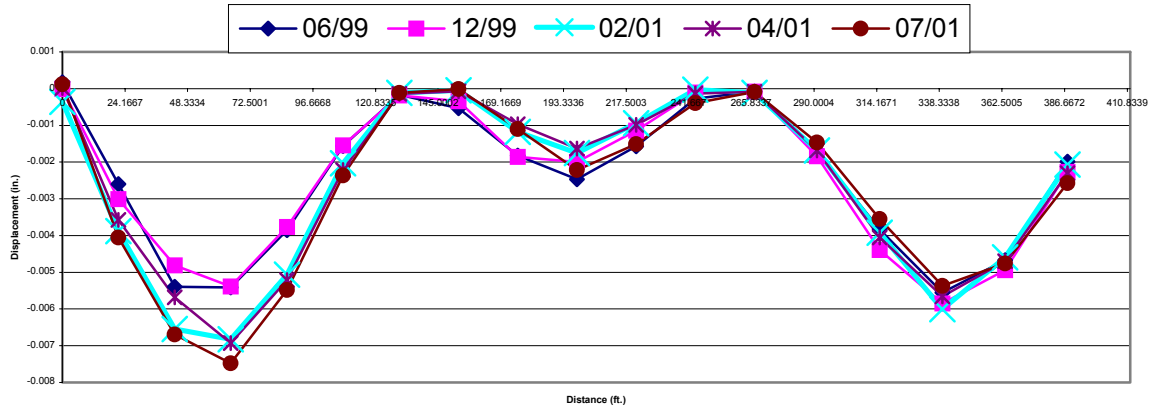
load vector composed of virtual downward loads of unit magnitude positioned at each measurement location along the girder line of interest. Figure 5a and 5b shows the displacement, for unit load, along girder three on the north and south side for several tests.

The first test, conducted in June of 1999 with the original reinforced concrete deck, was used as a baseline signature of flexibility for the structure. The test performed in December of 1999 was the first test conducted on the new FRP deck. It resulted in a displacement profile similar to the concrete deck, especially on the south side. However, it must be noted that this test data was initially corrupted by an impact node located coincident with a delamination “bubble” (which was only subsequently obvious after repeated traffic service).

Subsequent tests performed on the FRP deck show an increase in flexibility, or decrease in stiffness. One would expect the flexibility plots, for the tests on the FRP deck, to be in agreement with one another, but this can be explained. This difference can be attributed to repairs that were performed between December of 1999 and October of 2000. Initially, the panels were delaminating and had poor bearing on the steel superstructure.⁵ Follow-up tests reveal an increase in flexibility that is consistent for the three tests, two on the north side, since the repairs were performed. When comparing the original reinforced concrete deck to the FRP deck, it is apparent the flexibility of the structure has increased. This can be attributed to the loss of unintended composite action between the deck and girders.

Figure 5a: Flexibility for MOT-49 South Side

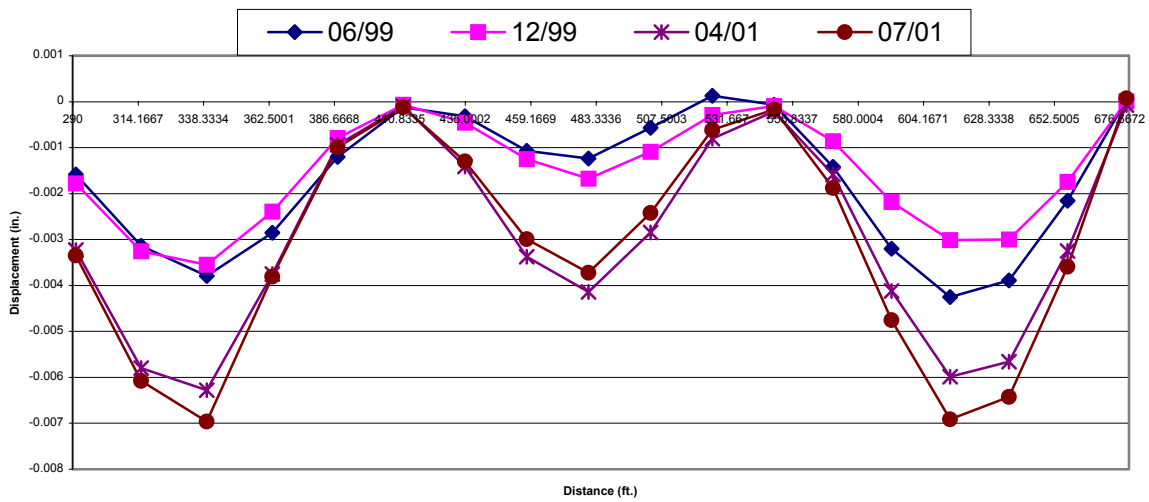
Figure 5b: Flexibility for MOT-49 North Side

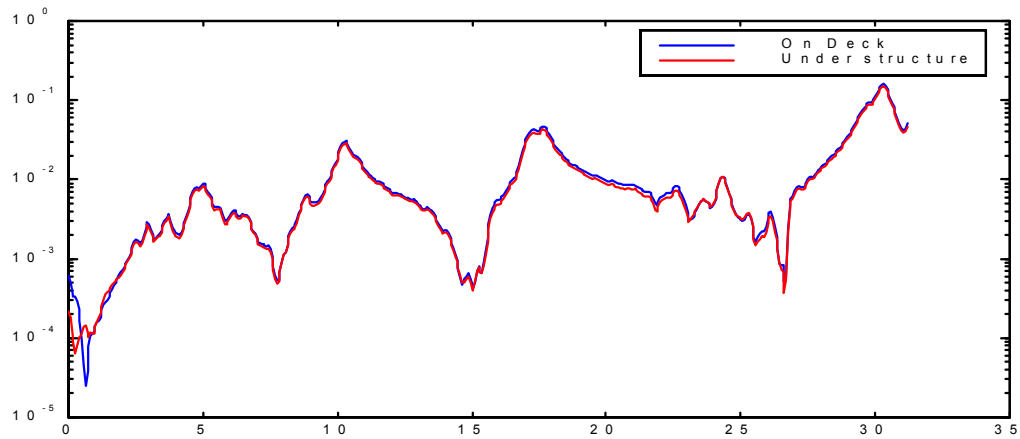
Instrumentation was installed for latter tests in order to confirm the integrity of the repaired seating of the FRP panels to the steel girders. Considering the many problems with the retrofitted panels, there was some concern raised with this bridge specimen as to whether the sensors mounted on the deck were measuring the response of the entire superstructure or simply the decking alone. Additional accelerometers were placed upon the girders themselves, directly beneath their sensor counterparts on the deck above (see Figure 2). A comparison of their frequency response functions (FRF) illustrates that the deck and girder are indeed acting as one in response to the controlled hammer impact (Figure 6). Differences are only evident at points where electronic noise dominates. Hence, the validity of the modal tests results were confirmed for the superstructure as a whole.

Figure 6: FRF comparison of deck and girder 3 in southernmost span
