# INFLUENCE OF FRP DECKING AS MEASURED THROUGH IMPACT TEST DATA

Michael S. Lenett<sup>(1)</sup>, Victor J. Hunt<sup>(1)</sup>, Arthur J. Helmicki<sup>(2)</sup>, Bahram Shahrooz<sup>(1)</sup>

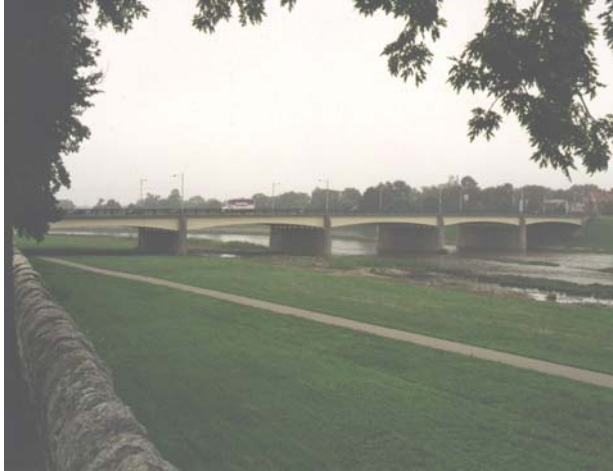
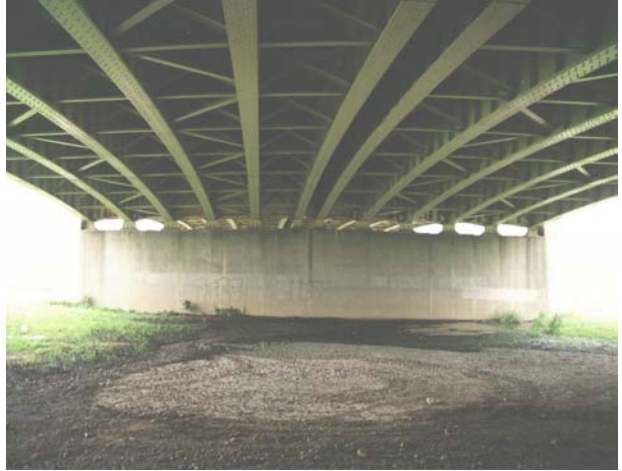
Figure 1: Overview of MOT-49-10.

The bridge whose reinforced concrete deck was replaced with interlocking FRP panel systems is located in Dayton, Ohio and is referred to as MOT-49-10 (Figure 1). This bridge consists of five spans, all of which cross the Great Miami River and its flood plain. Span lengths are, respectively, 130 ft., 137 ft., 145 ft., 137 ft., and 130 ft. and each span consists of six built-up steel girders (i.e., plate girders). Due to the long spans of the bridge, FRP deck systems from four manufacturers were installed. This was done in part to permit evaluation of the individual FRP systems when subjected to similar loadings and environmental conditions. Approximate locations of the various decks are shown schematically in Figure 2.

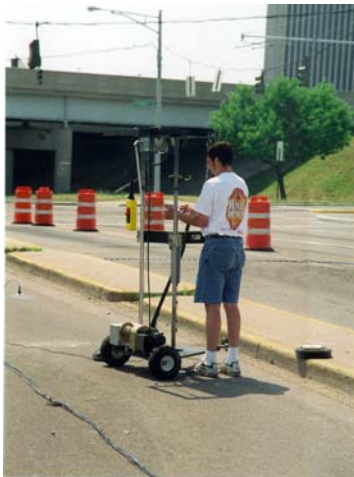
Figure 3b: Impact Hammer.

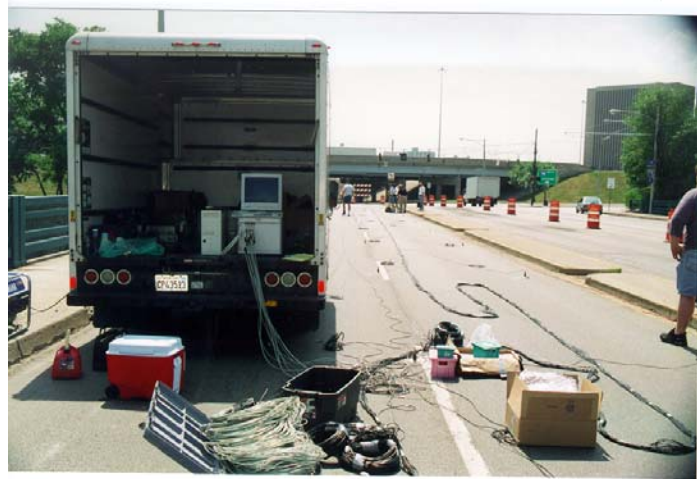
Figure 3c: VIXI system and South test setup.

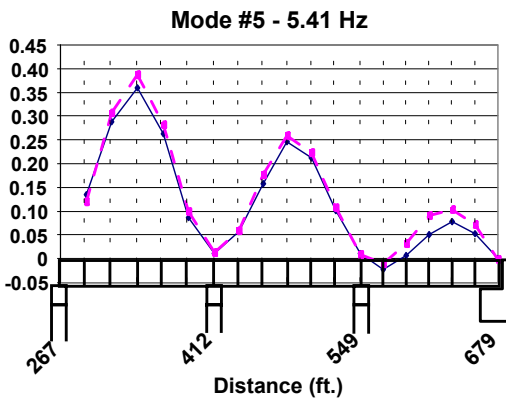
**"North" Test Mode Shapes  
Original Bridge (w/ Reinforced Concrete Deck)**

**"North" Test Mode Shapes  
Retrofitted Bridge (w/ FRP Deck Systems)**

**Figure 4: North test mode shapes identified for original and retrofitted bridge.**

Impact test data from both the North and South grids of the original and retrofitted bridge tests was used to identify mode shapes at natural frequencies ranging from approximately 2.5 Hz to 40 Hz. Several of these modes are depicted in Figure 4. Comparisons involving the first 8 modes of the original and retrofitted bridge tests are presented in Tables 1 and 2. These tables not only provide a comparison of natural frequencies, but also display, through MAC values, how well the respective modes correlate. As can be seen in Tables 1 and 2, certain mode shapes identified with retrofitted bridge data were not identified from original bridge data and vice versa. Furthermore, the North and South retrofit results presented in these tables reveal that the southernmost spans – the spans that use FRP-1, FRP-2, and FRP-3 panels – have slightly different modal characteristics than the northernmost spans which utilize the FRP-4 panel system. In other words, the type of FRP system installed on the bridge has a local effect on the dynamic behavior of the superstructure – different FRP systems have different local effects. Consequently, the results presented within Tables 1 and 2 essentially reveal that the dynamic behavior of the superstructure changes when the RC deck is replaced with FRP systems. The identified variations in dynamic behavior may be attributed to changes in superstructure stiffness induced through the FRP retrofit operations. However, changes in superstructure stiffness should also be reflected in the acquired/identified

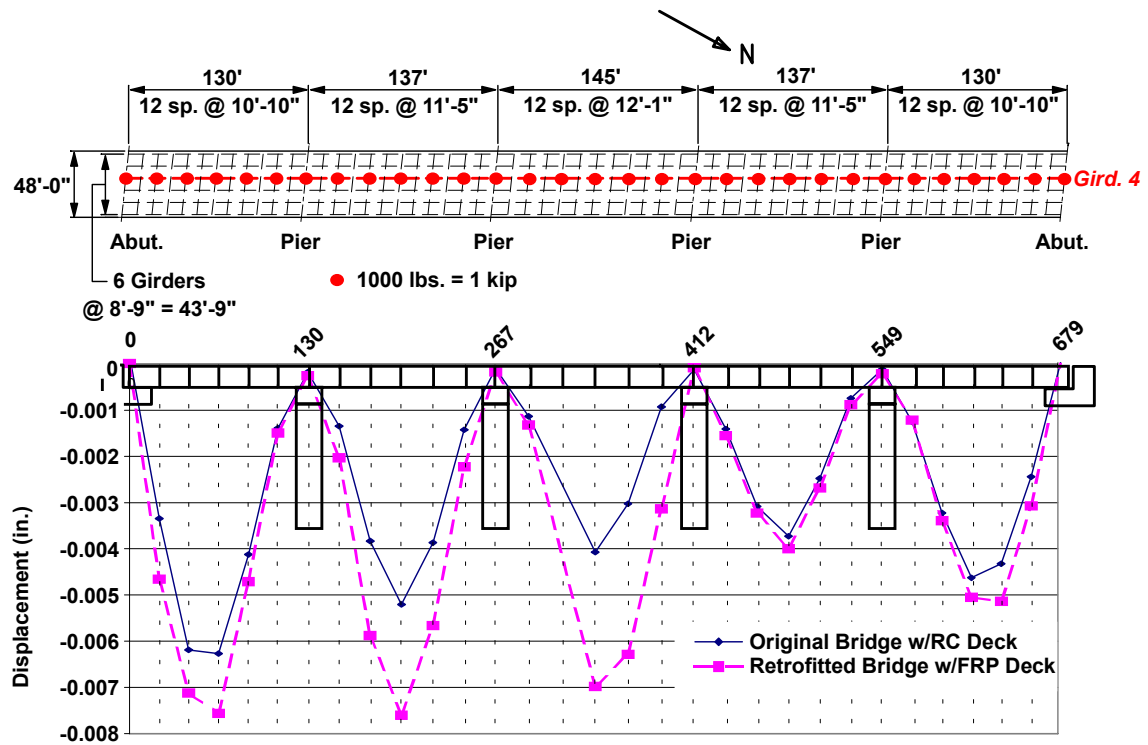
Figure 5: Comparison of original and retrofitted simulated displacements.

The in-situ flexibilities established in this manner for both the original bridge and retrofitted bridge were subsequently compared to evaluate what effects the installed FRP systems had on superstructure stiffness. Previous research has shown that the deflected shapes of a girder line are sensitive to damage and condition [2, 8], therefore, to permit a simple yet direct comparison, superstructure displacements along a particular girder line were used as the basis for all comparisons between the original and retrofitted bridge. The particular displacement profiles used for these comparisons were obtained by multiplying the respective modal flexibility matrices with a load vector comprised of virtual downward loads of unit magnitude positioned at each measurement location along the girder line of interest (Figure 5). Comparing the original and retrofitted displacement profiles (Figure 5) revealed an increase in flexibility, or decrease in stiffness, in the first three southernmost spans (using FRP-1, FRP-2, and FRP-3 systems) and a consistent measure of flexibility in the two northernmost spans (with FRP-4 deck system).
